ILLINOIS BUILDING INSPECTION, Inc.

BUILDING INSPECTION REPORT

INSPECTION ADDRESS: XXXXX W. Taylor Chicago, Illinois

DATE OF INSPECTION: July 1st, 2008

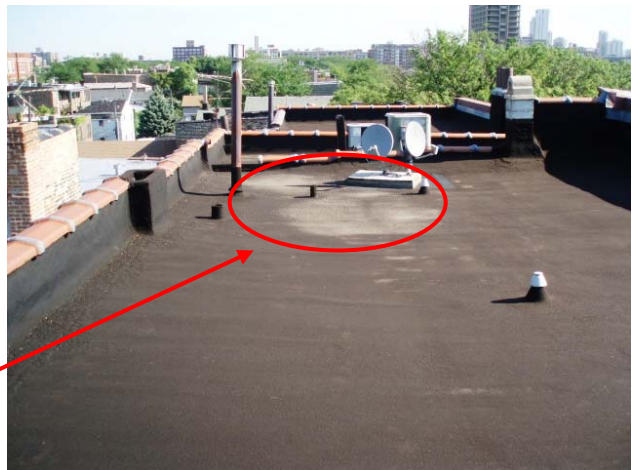
FYI There is a low spot in the roof where water has been ponding. Ponding water will magnify the sun's destructive ultra-violet rays, and such will cause this low area to suffer quicker-than-normal roof membrane deterioration. Have this spot checked yearly and patched as/if needed.

Here, in this area...

1.	FYI---- There is a low spot in the roof where water has been ponding. Ponding water will magnify the sun's destructive ultra-violet rays, and such will cause this low area to suffer quicker-than-normal roof membrane deterioration. Have this spot checked yearly and patched as/if needed.

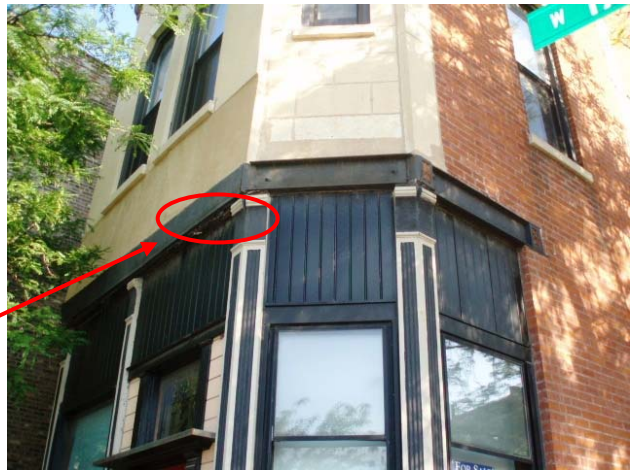
Major Repair At the SE corner of the commercial unit, one of the steel beams/lintels is severely corroded, and the cracking in the wall above suggests the lintel/beam is failing. Have the beam/lintel replaced or bolstered as needed.

Up here...

2.	Major Repair At the SE corner of the commercial unit, one of the steel beams/lintels is severely corroded, and the cracking in the wall above suggests the lintel/beam is failing. Have the beam/lintel replaced or bolstered as needed.

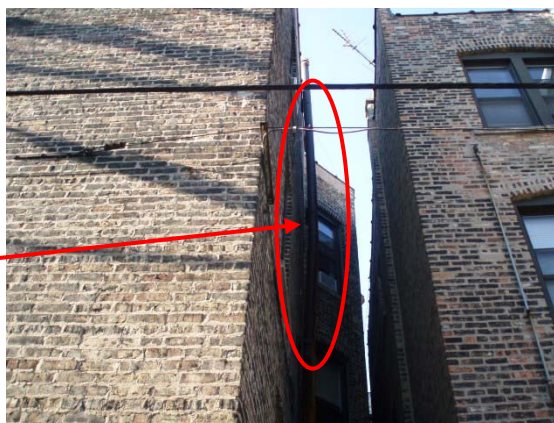
Minor Repair The exterior flue chimney serving the basement furnace is loose and needs to be re-secured to the west exterior wall.

This loose chimney...

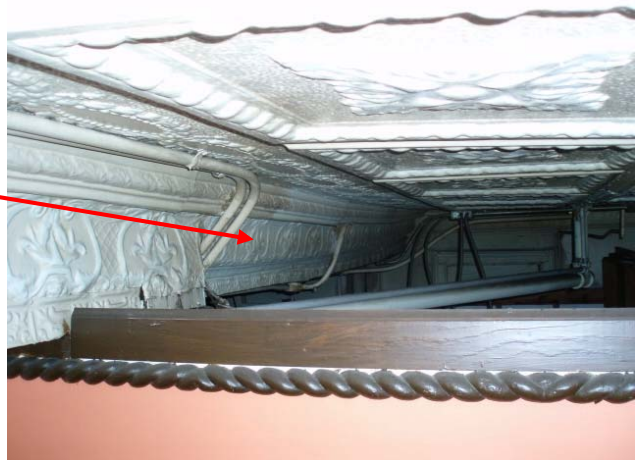
Major Repair (And Significant Safety Concern...) The front main stairway is on the verge of collapsing. Don't even think about using this stairway. The stairway is collapsing due to a defective main support beam that runs directly above the west wall in the commercial unit. (This is also why the walls are cracked and the floors are sloped in the second floor front apartment, as mentioned earlier in this report.) Most of this defective beam is covered with finish materials, so I don't know the extent of the beam damage, but above the kitchen ceiling in the commercial unit, I can see part of this obviously-failed beam. **Fixing the defective beam, the collapsing stairway, the sloped apartment floors, and the cracked apartment plaster is going to cost a lot of money.**

This is where I saw the failed main structural support beam section...
