HOUSE INSPECTION REPORT

INSPECTION ADDRESS: 9254 XXXXXXXX Court Frankfort, Illinois

DATE OF INSPECTION: October 21st, 2008

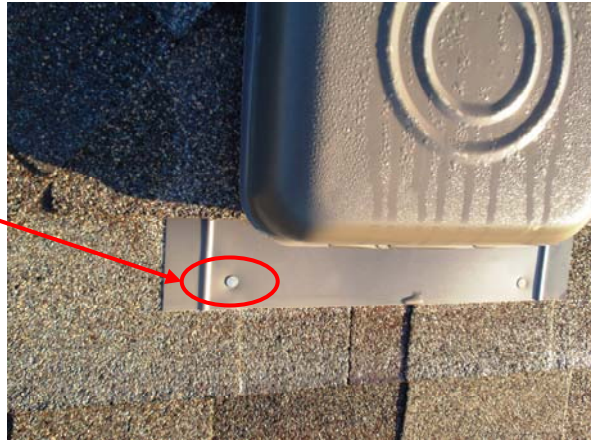
Minor Repair Exposed nail heads found at the base of vent flashings &/or at the end-ridge shingles can corrode and may allow leakage. These exposed nail heads should be dabbed with sealant to prevent or arrest corrosion.

These such exposed roofing nail heads...

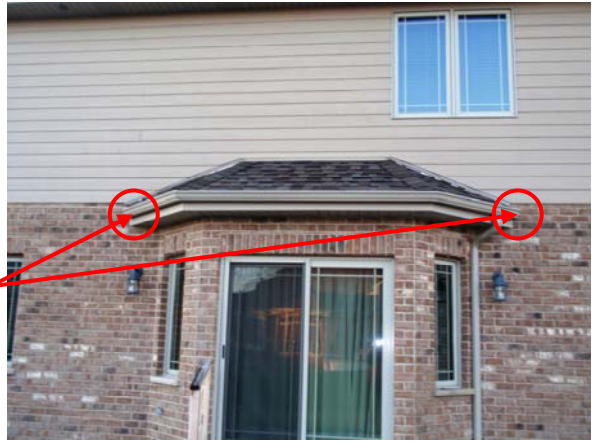
Minor Repair The gaps either side of the small roof section above the rear sliding door need to be sealed with metal flashing to prevent leakage.

The gaps are at these two lower roof corners...

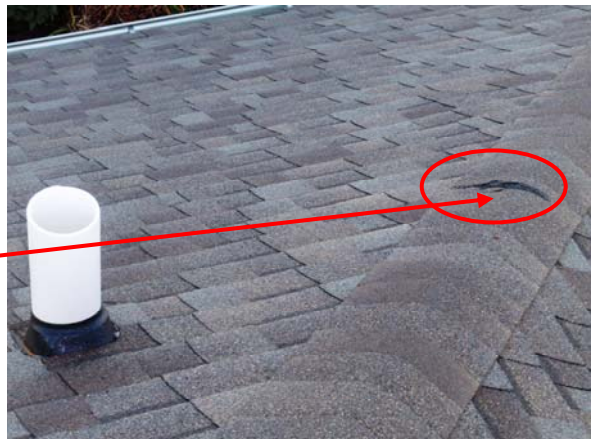
Minor Repair On the hip-ridge at the NW quadrant of the upper roof, a damaged ridge roof shingle needs to be replaced.

Here...

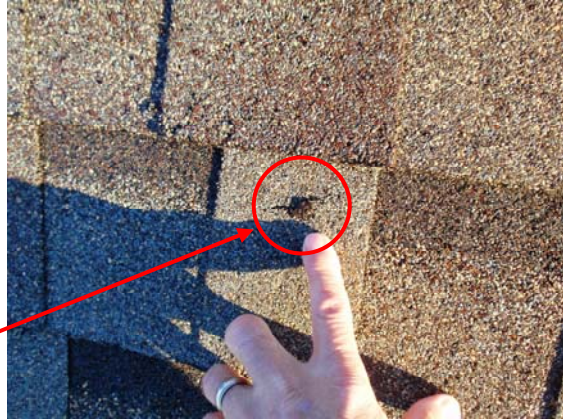
Minor Repair A few (three or four) of the roof shingle nails are popping-up through the shingles above, and these punctured shingles will allow leakage. Have the up-lifting nails & nail holes patched. Where? In a few spots of the roof...a roofer will easily see such nails within a few seconds of looking around.

Popped nails like this one...

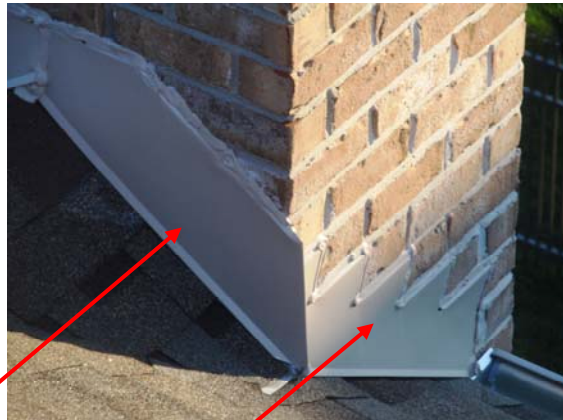
FYI The back (west) face of the masonry chimney is not properly sealed with metal flashing. The upper edges of the flashings are not *stepped*, and this will allow leakage. The flashing needs to be removed and replaced with proper step-flashing. I don't know if this will be a Major Repair Item or a Minor Repair Item; it could go either way. Talk with a roofing contractor about what it will take and cost to address this.

This flashing...

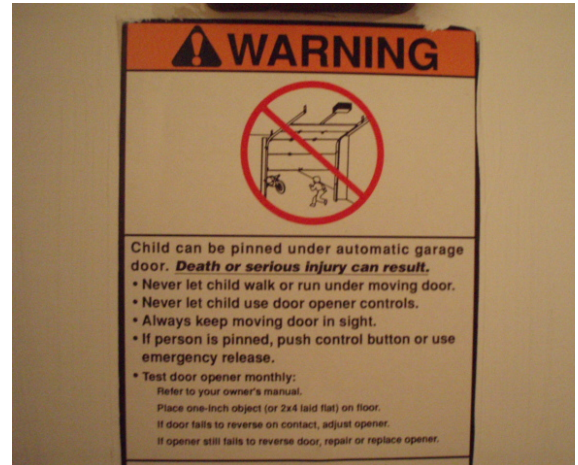
Safety Concern There is supposed to be a Child Safety Warning Label for the garage overhead door’s automatic opener posted right next to the opener’s control button. The missing warning label should be obtained and posted.

This is what the label looks like...

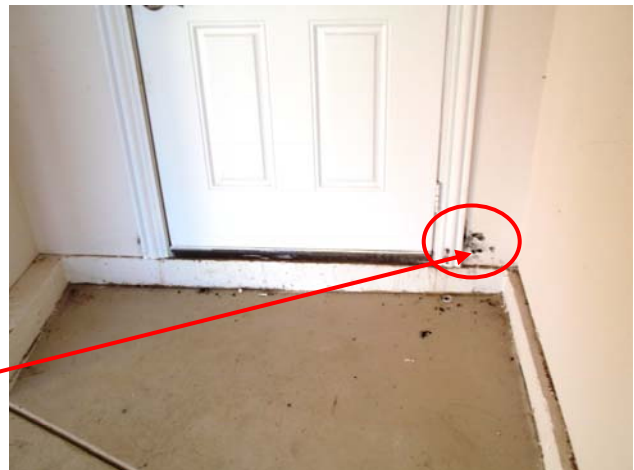
FYI Mold is growing on the back garage wall by the garage-exterior door. Nothing outside appears to be allowing leakage that’s promoting the mold growth; I think someone stored something damp up against this wall. Wash the mold off with bleach.

Here...

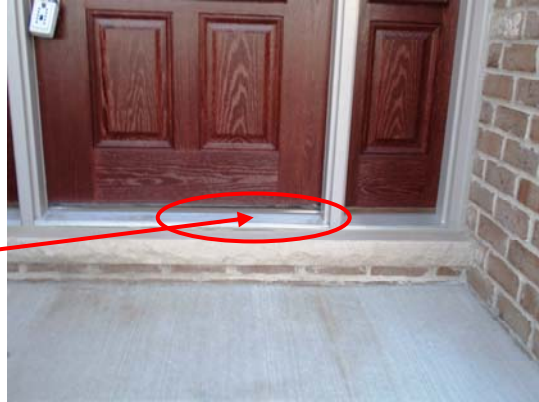
Minor Repair The gaps under the front entry door and under the front door threshold need to be sealed to prevent air & water leakage.

Down here...

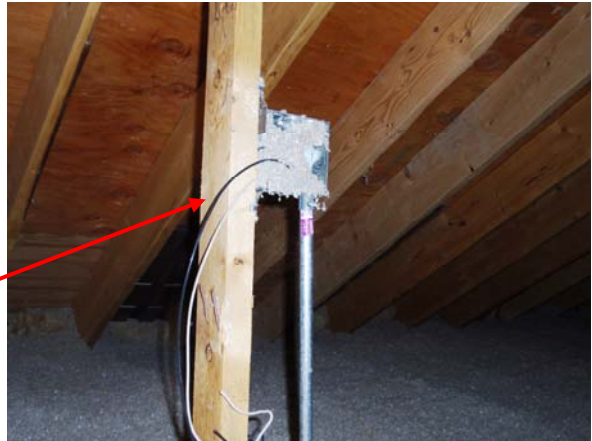
Safety Concern The missing light fixture in the garage attic needs to be installed. (The live, bare electrical wires sticking out of the electrical light-box in the attic pose both a shock and a fire hazard.)

These live electrical wires...

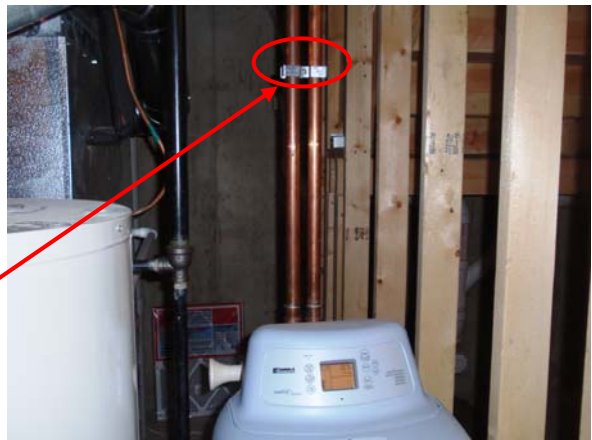
Minor Repair The electrical steel bonding clamp on the copper water pipes right above the water softener needs to be replaced with a copper electrical bonding wire. The steel clamp connected to the copper water piping can promote galvanic corrosion and water pipe leakage.

This bond clamp...

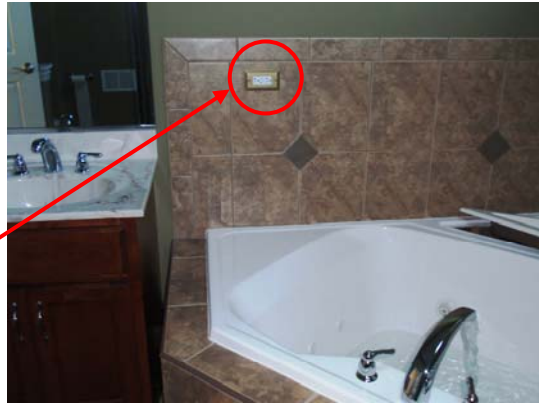
Safety Concern The electrical wall receptacle located above the master bathtub needs to be moved, now, so it's not located above the tub. Locating an electrical wall receptacle above a bathtub poses a shock hazard (for obvious reasons).

This receptacle... (stupid, stupid, stupid).

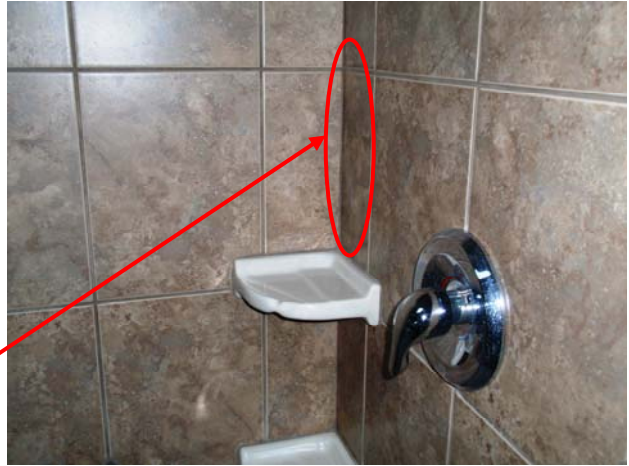
Minor Repair Cracked vertical-corner grout joints in the tiled walls surrounding the tubs and showers should be caulked to reduce water penetration and the possibility of deterioration. (Note: The wall substrate behind the tiles was more than gently tapped to check for substrate moisture damage; none was detected.)

Cracked-open corners like this one...

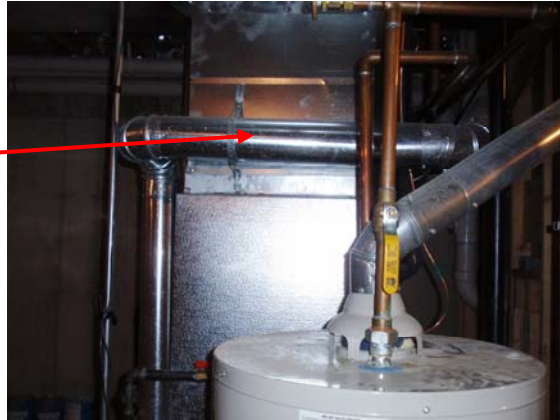
Safety Concern Part of the furnace flue piping is lacking the safe and required (minimum) 1/4" rise per running foot, posing a carbon monoxide hazard. The flue piping should be re-pitched so as to have at least 1/4" rise per running foot.

This back-pitched furnace flue pipe...

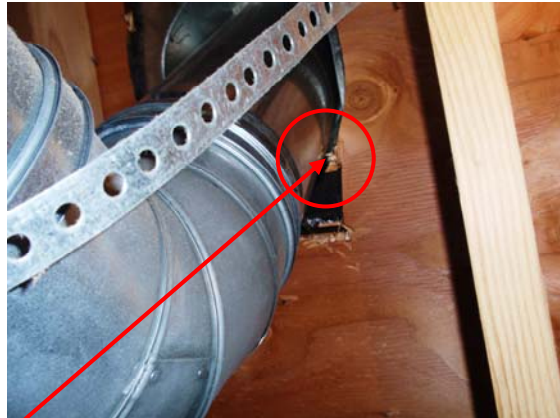
Safety Concern Up in the attic, part of the double-wall furnace flue pipe is lacking the safe and required 1" clearance to the combustible wooden roof decking near the flue pipe. The heat from the hot flue pipe dries out the combustible material and lowers its kindling temperature (pyrolysis). This poses a fire hazard. Safe and proper clearances should be attained ASAP.

This roof plywood is way too close to the hot flue pipe...

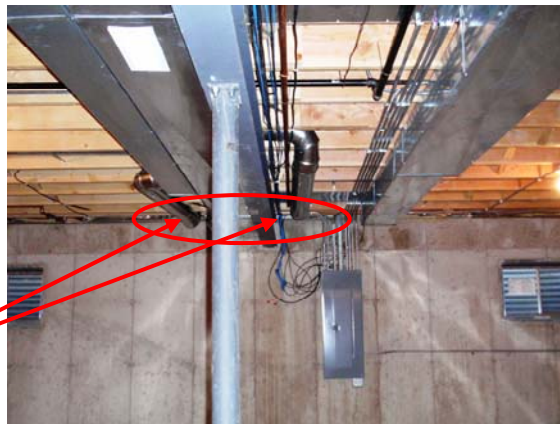
Minor Repair The heating duct for the west living room and dining room floor registers is not, at all, properly installed. You can see the poor (idiotic) duct installation down in the basement ceiling below the floor registers. Have a *qualified* heating contractor properly re-install the ductwork.

You can see the poor ducting up here...

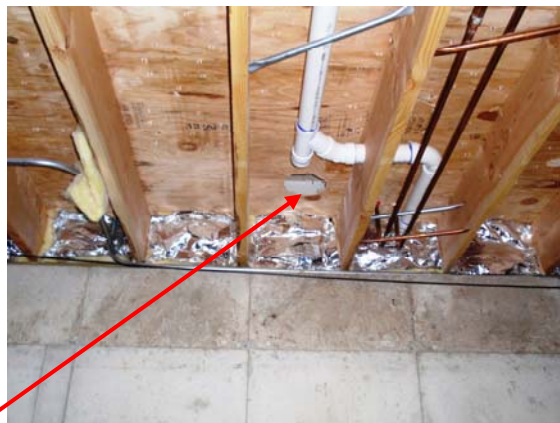
Minor Repair The heat duct was never installed for the kitchen's sink-cabinet toe-kick register, nor was the toe-kick register. The kitchen is not heated. Have the missing ductwork and register installed. (A hole was cut in the basement ceiling to accommodate the ductwork, but again, the ductwork and register were never installed.)

Here's the hole in the floor, for the missing duct...

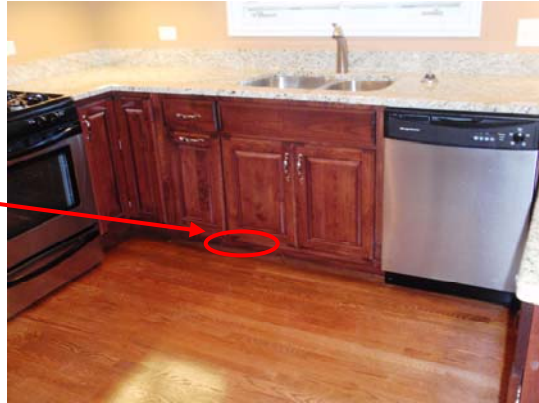
Here's where the missing kitchen cabinet toe-kick heating register belongs...

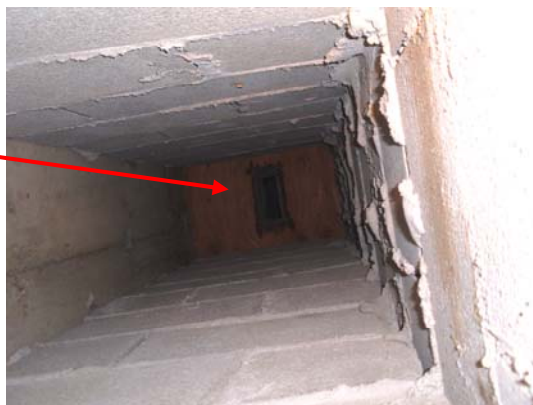
Safety Concern The temporary wooden form used to construct the fireplace hearth was never removed from underneath the fireplace after the fireplace was completed. Wood remaining below a fireplace poses a fire hazard. The heat from fires dries-out the wood and lowers its kindling temperature (pyrolysis) and a spark or an ember falling through the ash-dump door or through a crack in the masonry could easily ignite this form. The fireplace should not be used until the wooden form is removed. (This is going to require a fair amount of work as masonry blocks down in the basement will have to be removed to get the wood form out.)

This wood form (picture taken with a camera stuck into the fireplace ash-dump cleanout chute down in the basement).

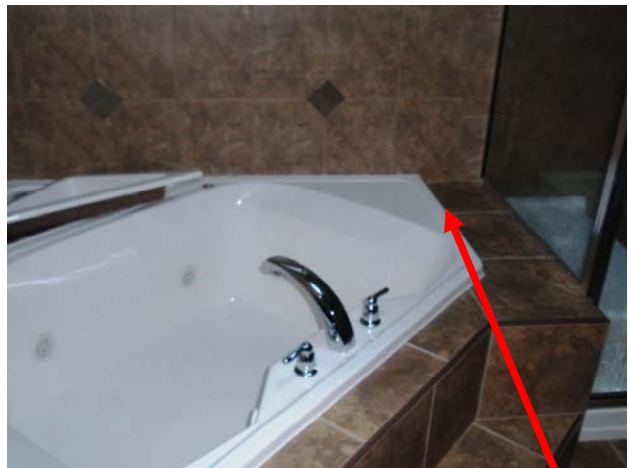
Investigate Further There is at least one substantial void in the exterior wall insulation under and behind the master bath whirlpool tub. If it gets cold enough for long enough, you run the real risk of having the tub water supply pipes freeze and burst and cause catastrophic flood damage. I don't know if this will be a Major Repair Item or a Minor Repair Item to correct; it could go either way. Talk with an insulation contractor about what it will take and cost to address this. Have the insulation void eliminated A.S.A.P.

The void in the exterior wall insulation is back under here (seen by looking into the tub access panel).
