ILLINOIS BUILDING INSPECTION, Inc.

BUILDING INSPECTION REPORT

INSPECTION ADDRESS: XXXXX W. Taylor Chicago, Illinois

DATE OF INSPECTION: July 1st, 2008

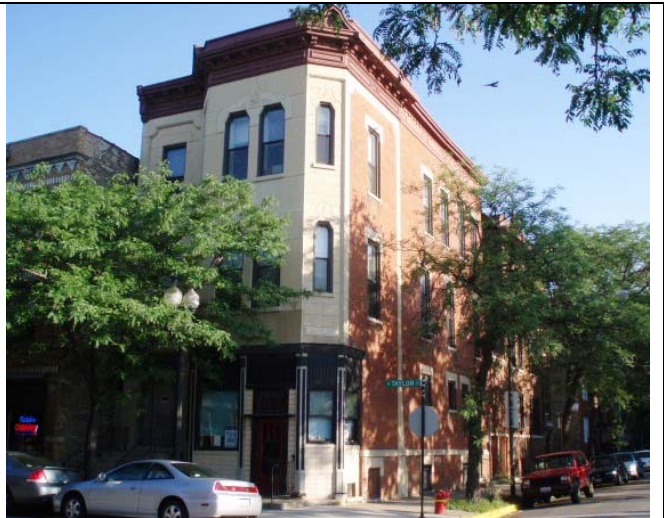
FYI There is a low spot in the roof where water has been ponding. Ponding water will magnify the sun's destructive ultra-violet rays, and such will cause this low area to suffer quicker-than-normal roof membrane deterioration. Have this spot checked yearly and patched as/if needed.
