HOUSE INSPECTION REPORT

INSPECTION ADDRESS: 9254 XXXXXXXX Court Frankfort, Illinois

DATE OF INSPECTION: October 21st, 2008

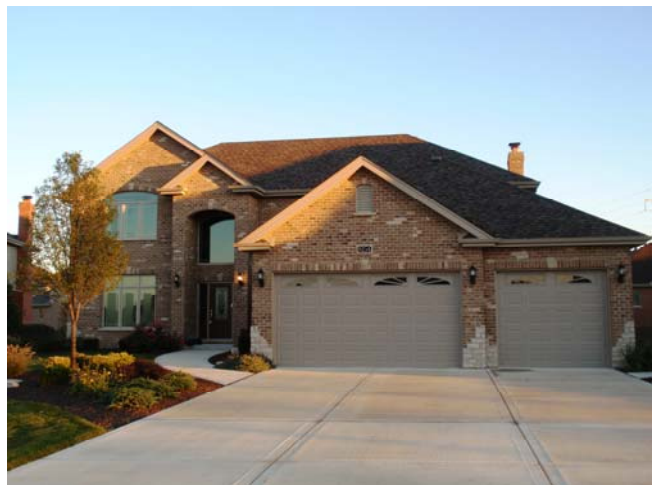
The weather was cool and sunny. The outdoor temperature during the inspection was about 50 degrees.

The soil was dry. It hasn't rained in the past week.
